## CASE STUDY CONSULTANCY FOR THE NHBC

Situated in the bustling sailing port of Fowey on the picturesque south Cornish coast, Blue Mills is a unique development of contemporary apartments enjoying breath taking views of the magnificent Fowey estuary. Once a magnificent building in the heart of Fowey, it soon fell foul of poor design features and a lack of consideration for the movement of the timber frame structure.

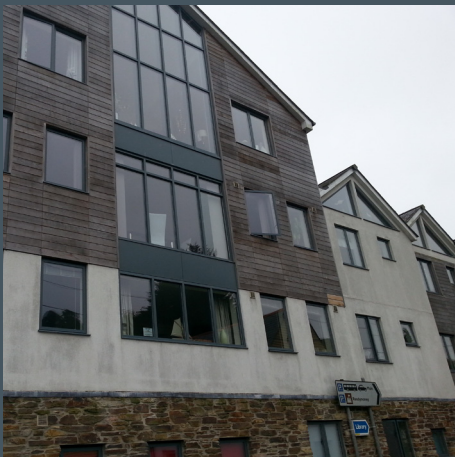
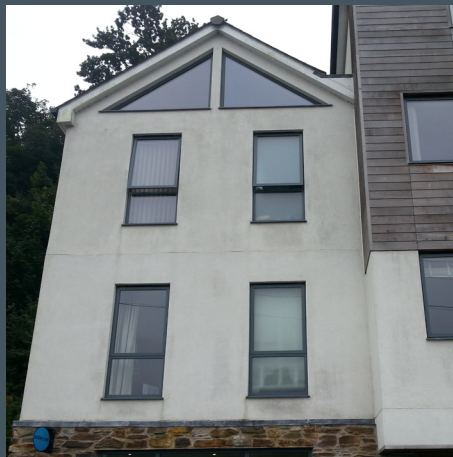
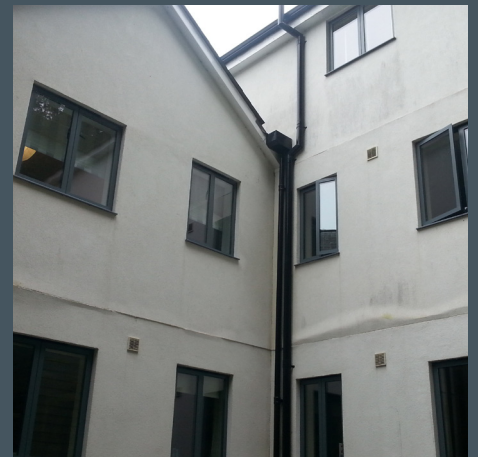
Algae soon started to form around the areas below windows. Cracks started to appear at internal corners and the render started to bulge and debond at floor levels, where inadequate precautions and consideration had been taken to the movement and settlement of the timber frame. This once proud development had become an eyesore on the Fowey landscape.

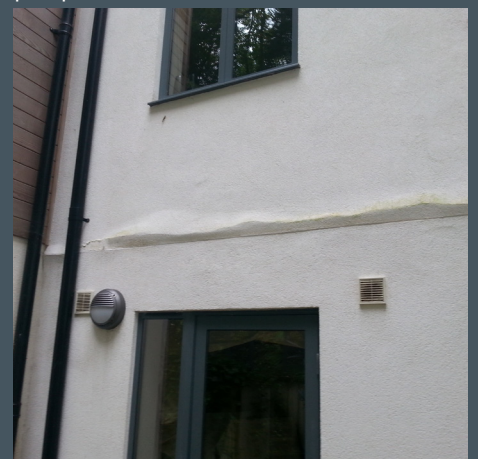
with an understanding of the issues present with the buildings. Following further site visits and minor exploratory work, it soon became clear that movement, an integral part of any design consideration for timber frame construction, had become an afterthought, along with inadequate size, layout and fixing of the timber battens. This had resulted in the NHBC Claims department being faced with various issues here. Prior to agreeing any remedial works, a senior engineer from the

NHBC attended the development with SAS to inspect the exposed system and agree general proposals for rectification work.
